# Thermal Scanning Services: Aerial IR Building Envelope Audits

# Agenda

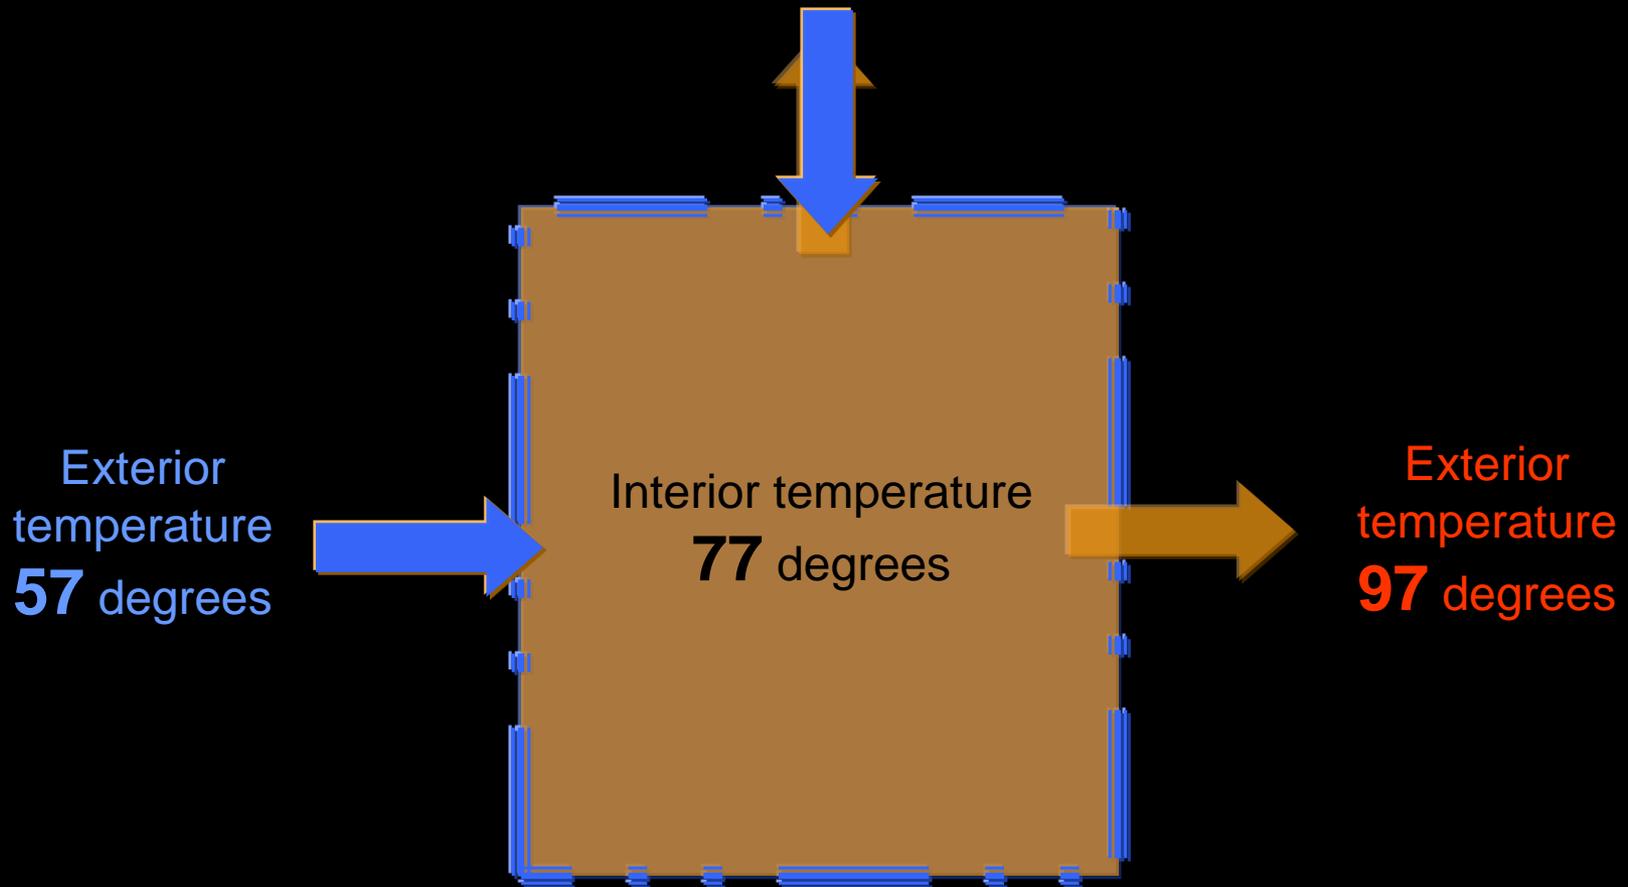
# Thermography is based On Temperature DIFFERENCES

Need at least a 20 degree differential

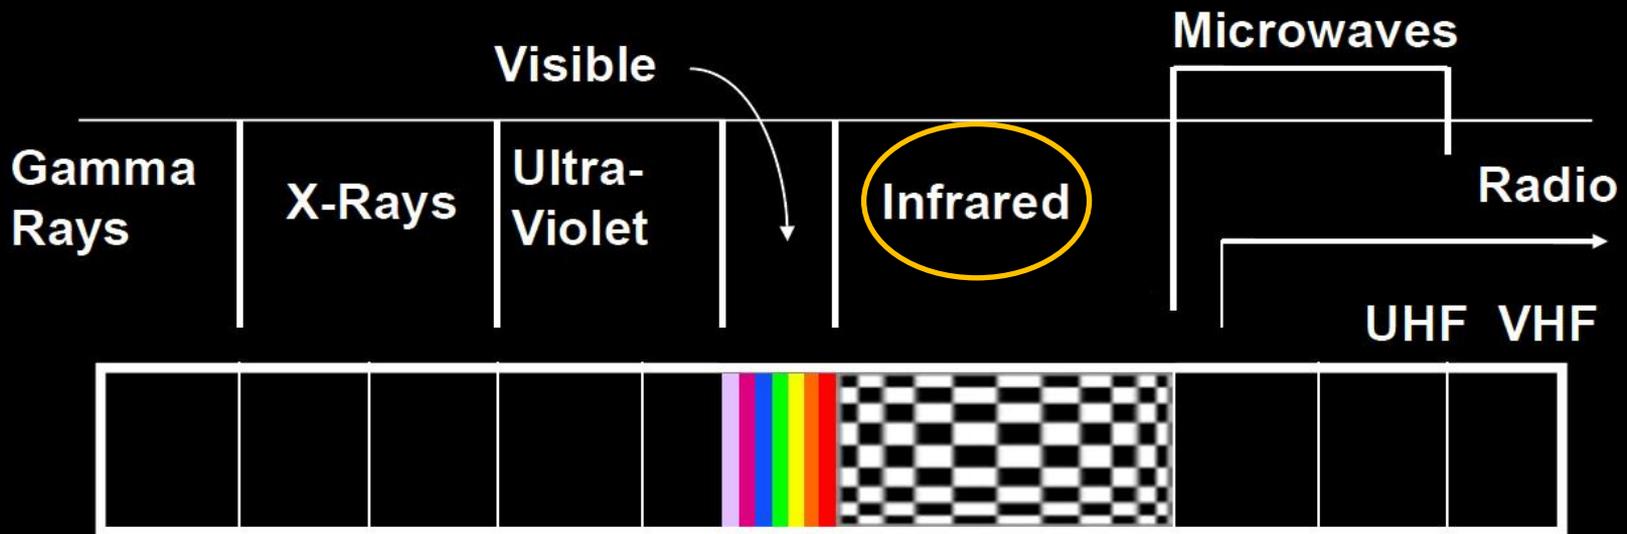
High Definition Infrared Radiation  
(640x480)

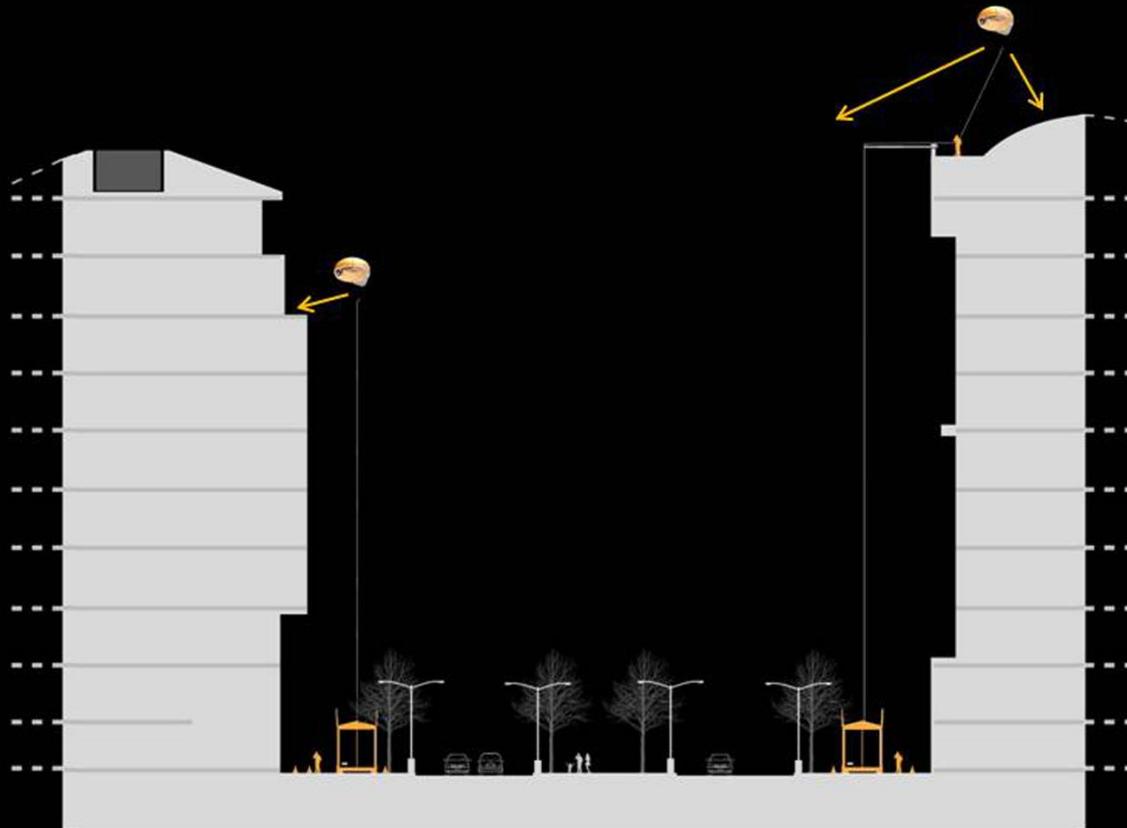
The IR camera hoisted from the balloon can see hidden areas.

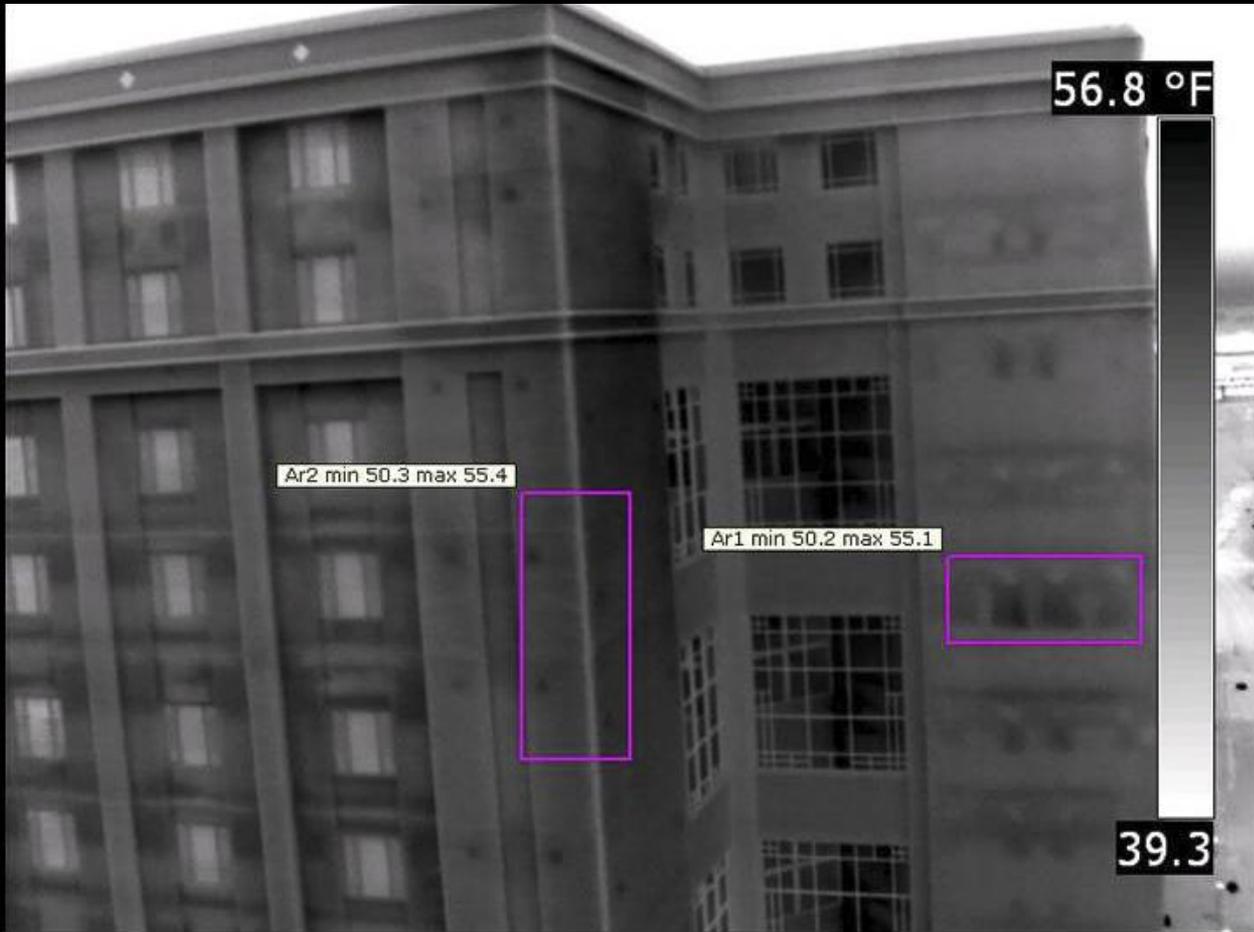
The dark (warm) spots show poor wall design and missing insulation at this judiciary building.

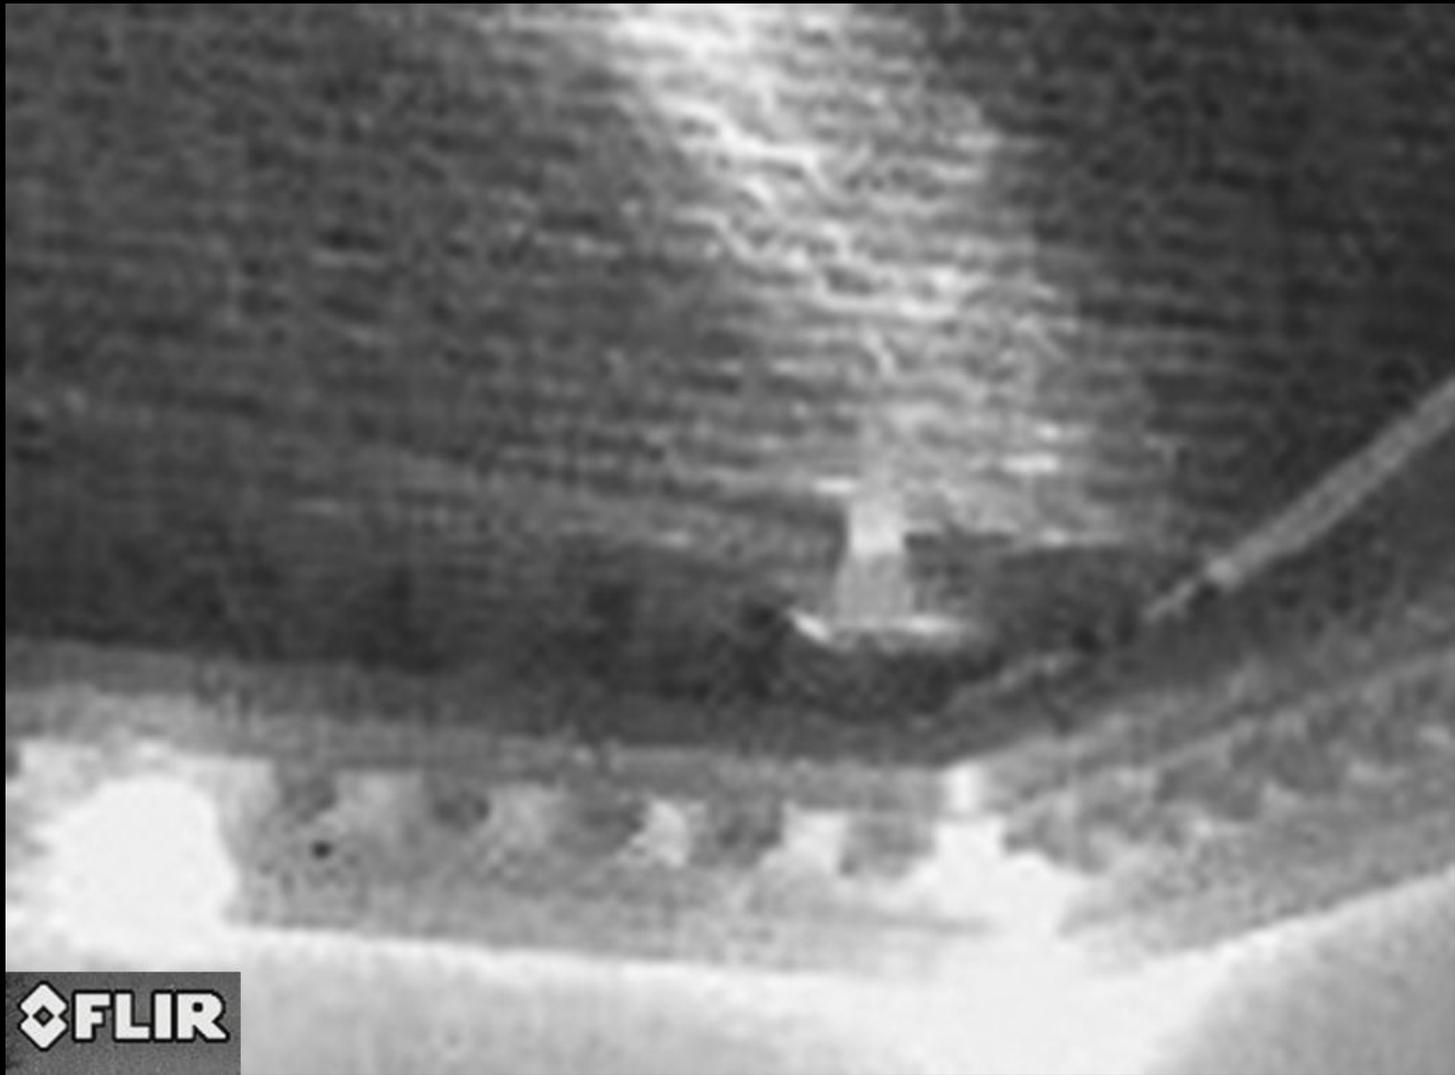
Detail: 640x480 Resolution

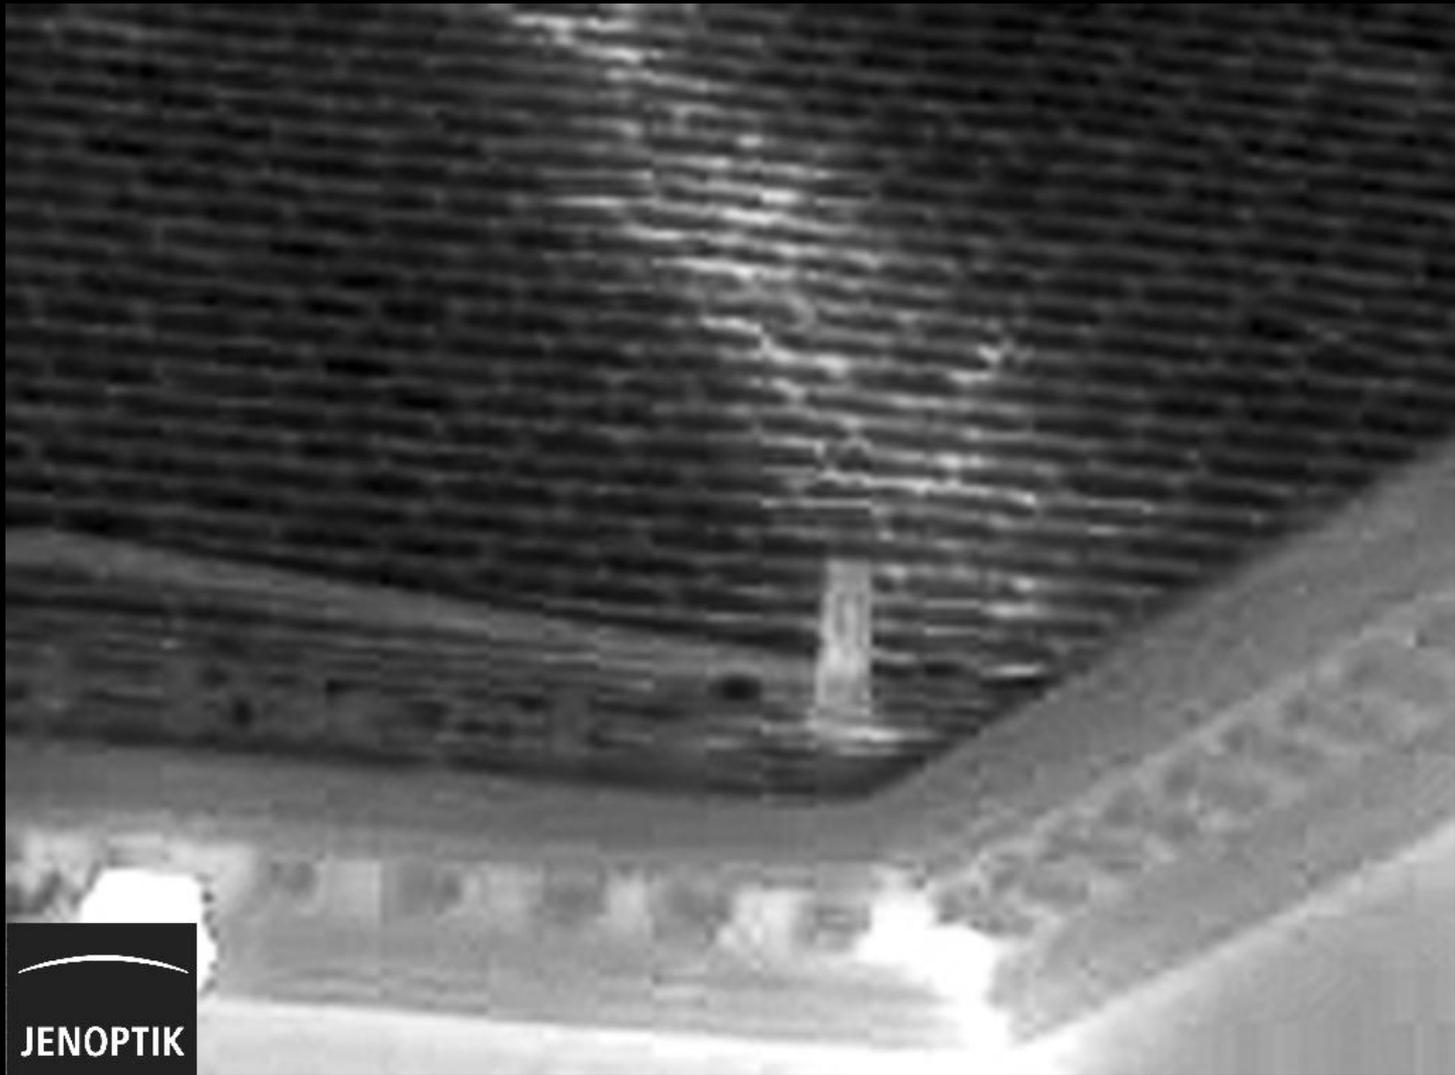
Detail: 1024x768 Resolution

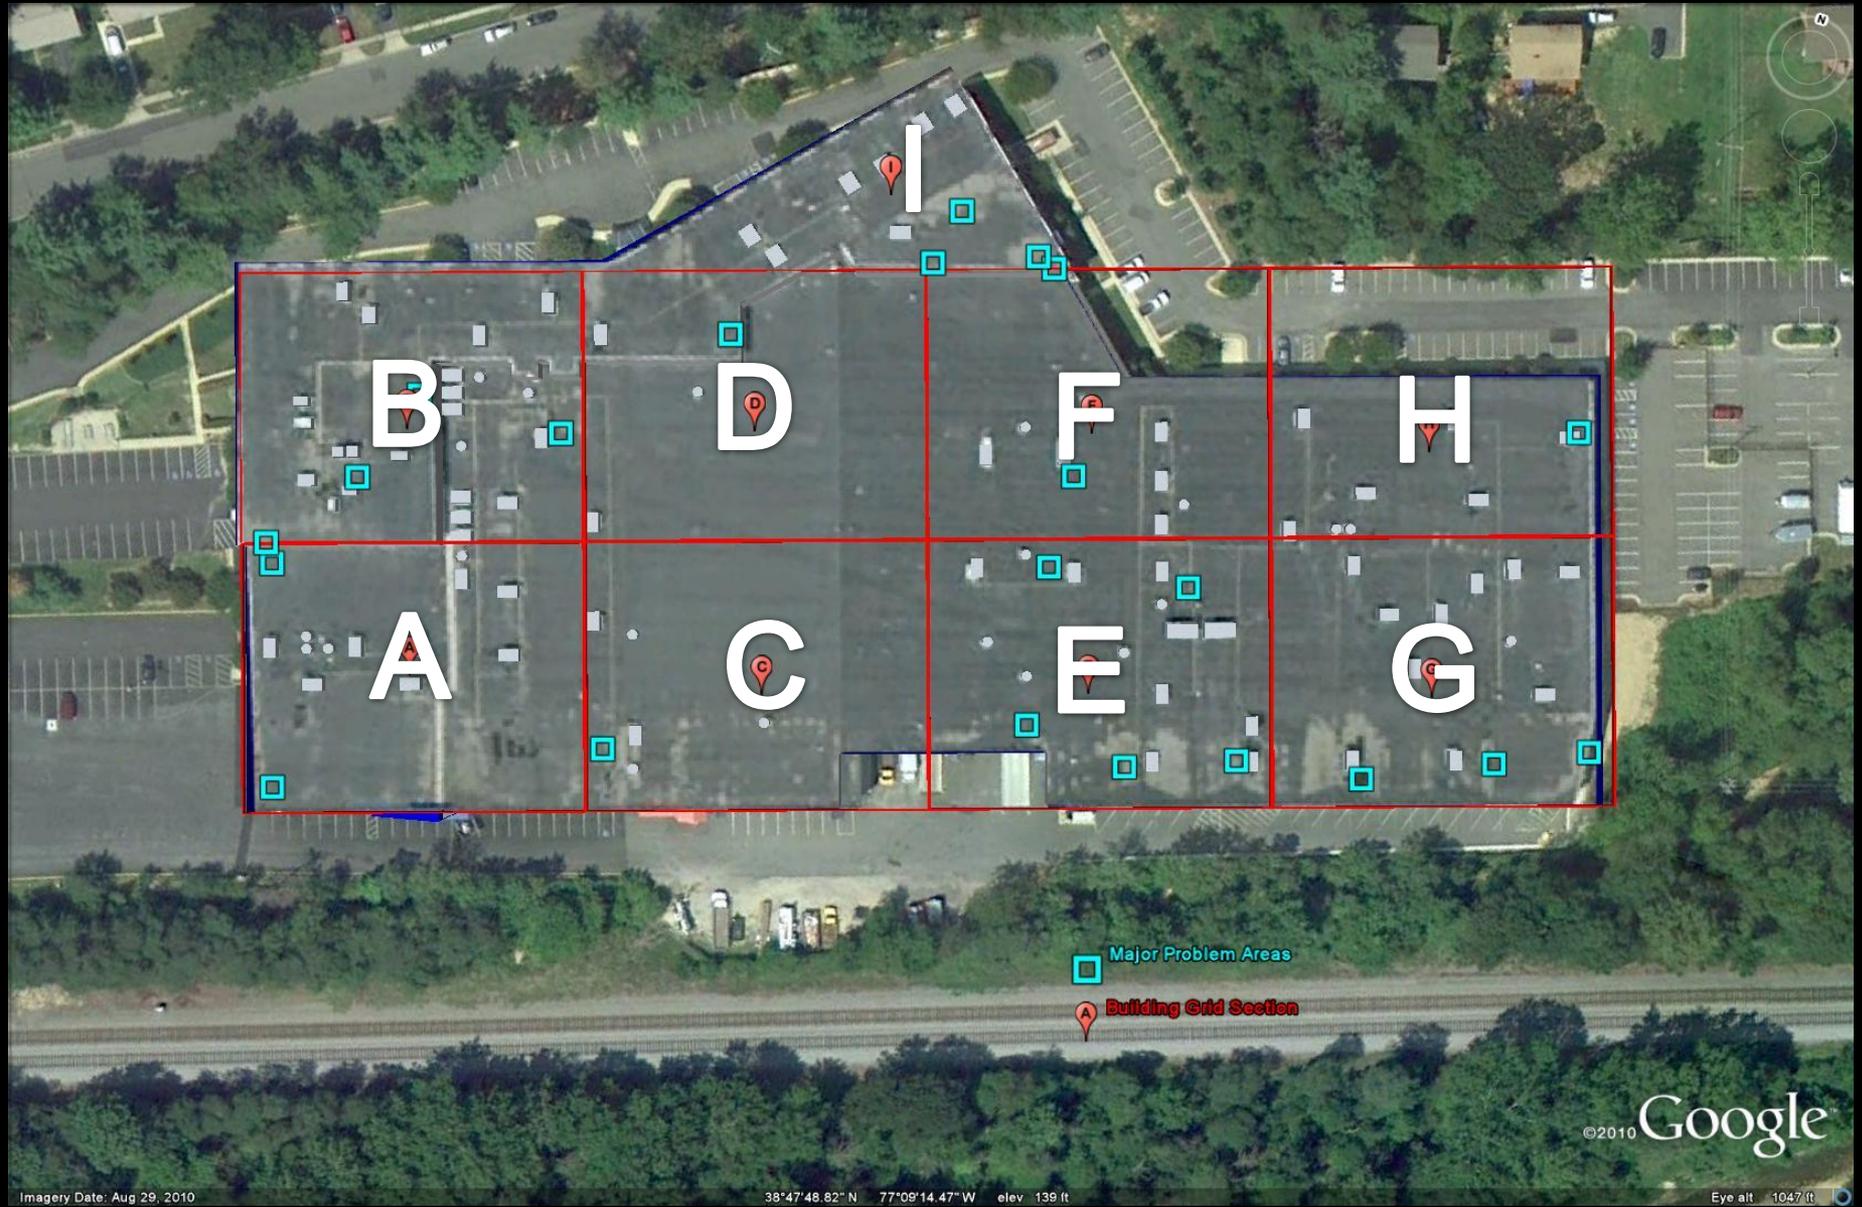
For easier analysis, the building has been divided into a simple grid formation. Grid Sections are used to locate IR photos on the rooftop and along the façade.

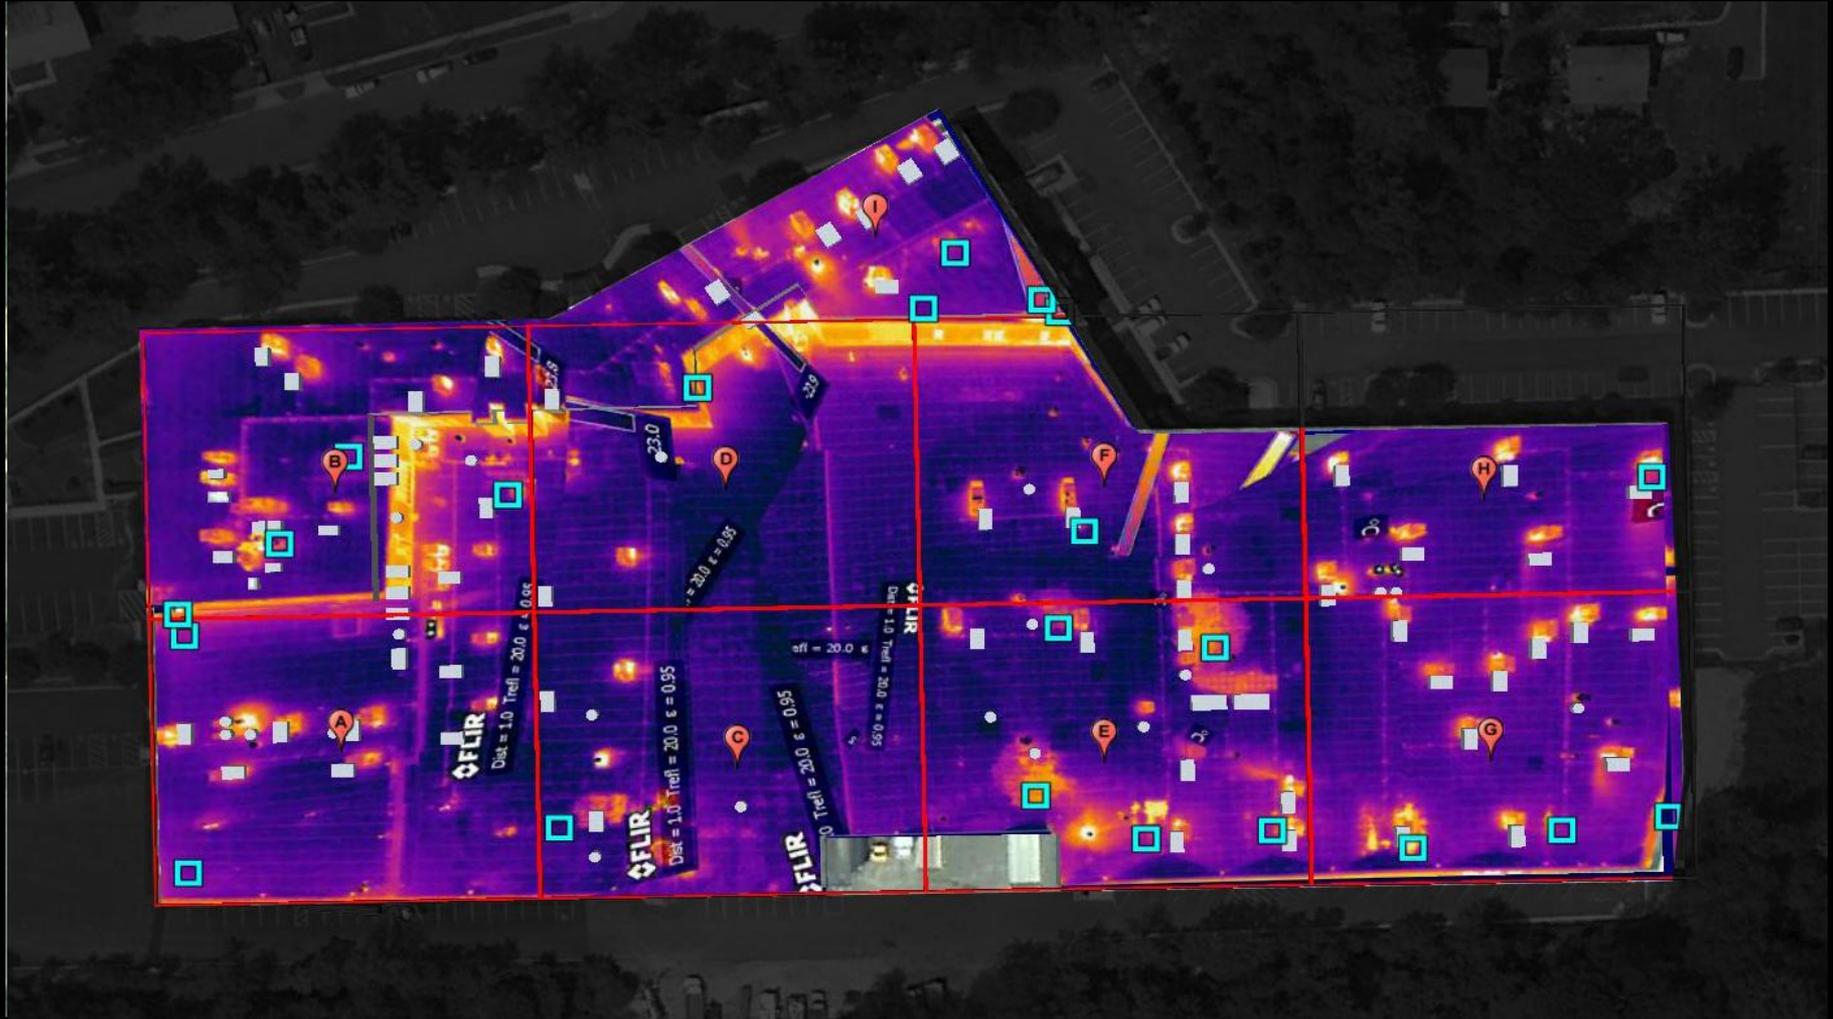
The light blue boxes indicate the major thermal insulation issues.

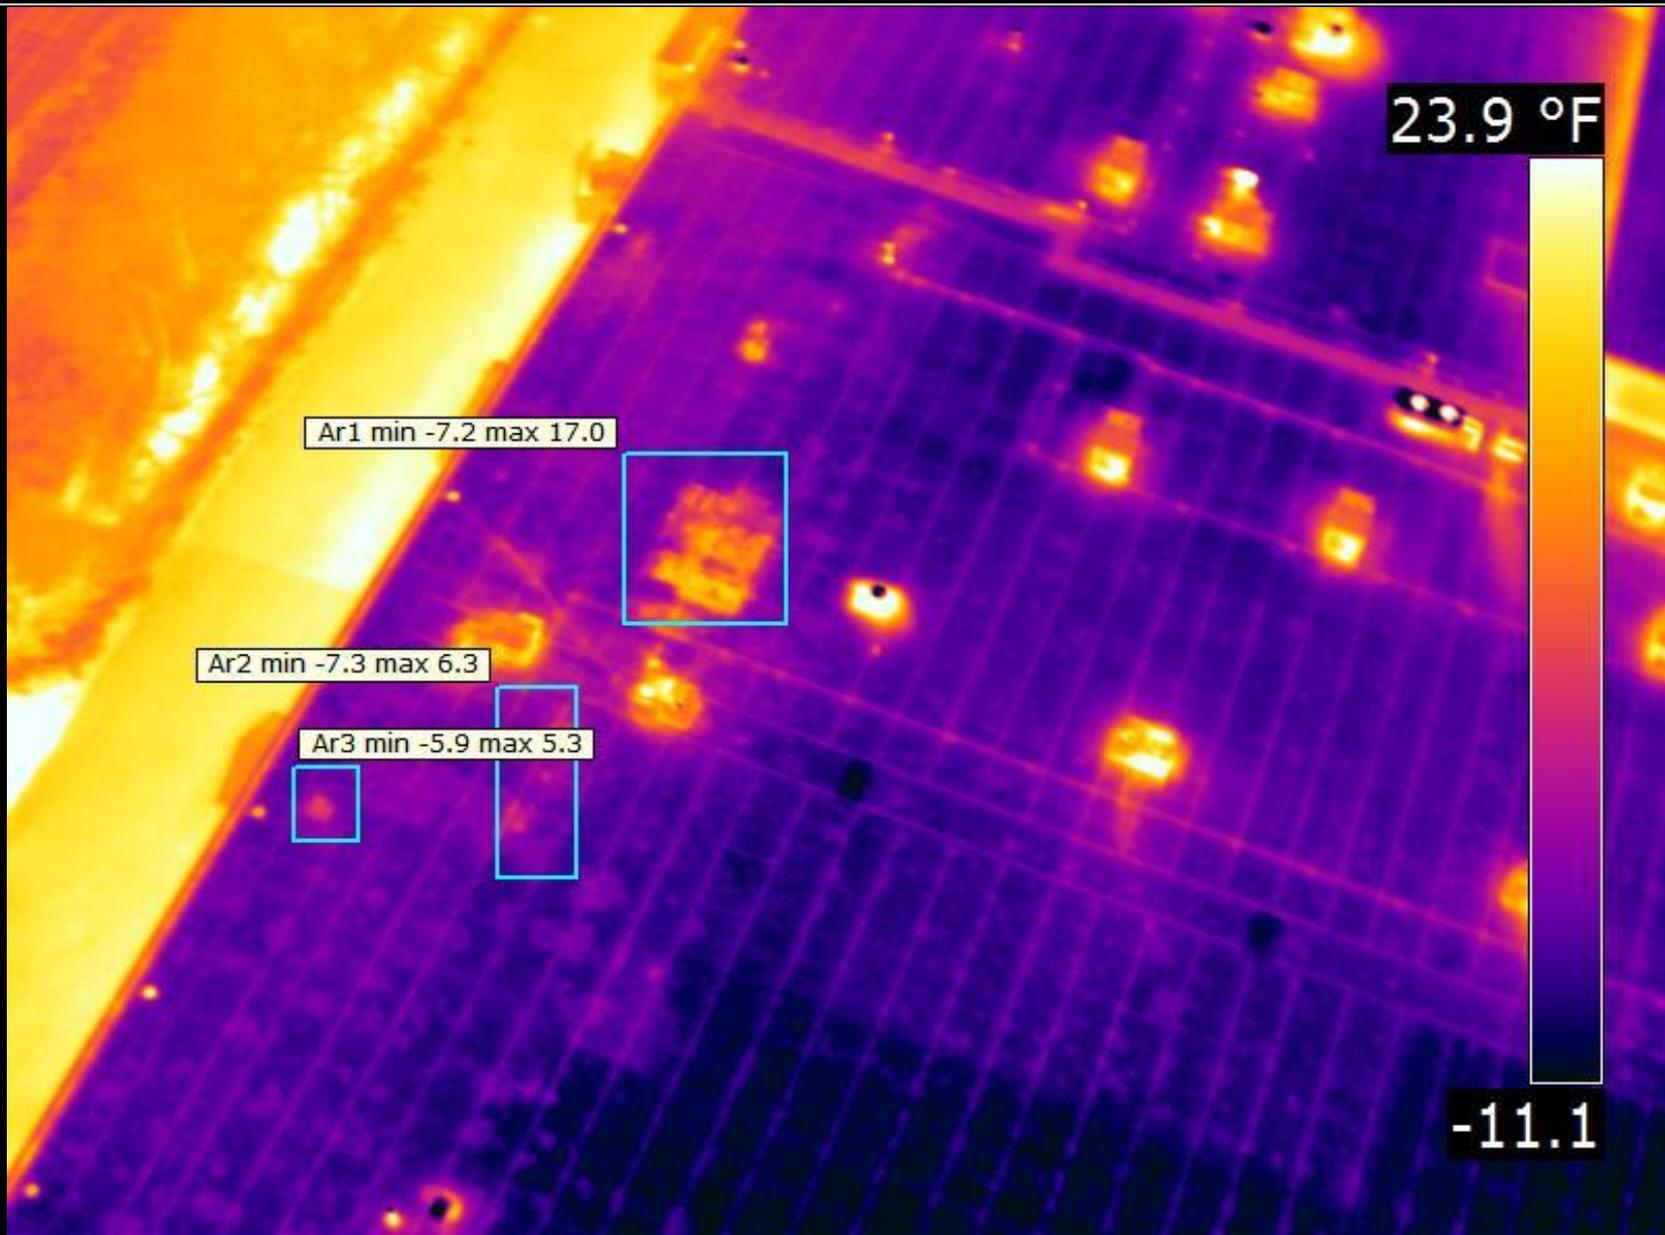
Overall view of Section C. Major problems have been marked by indicator boxes.

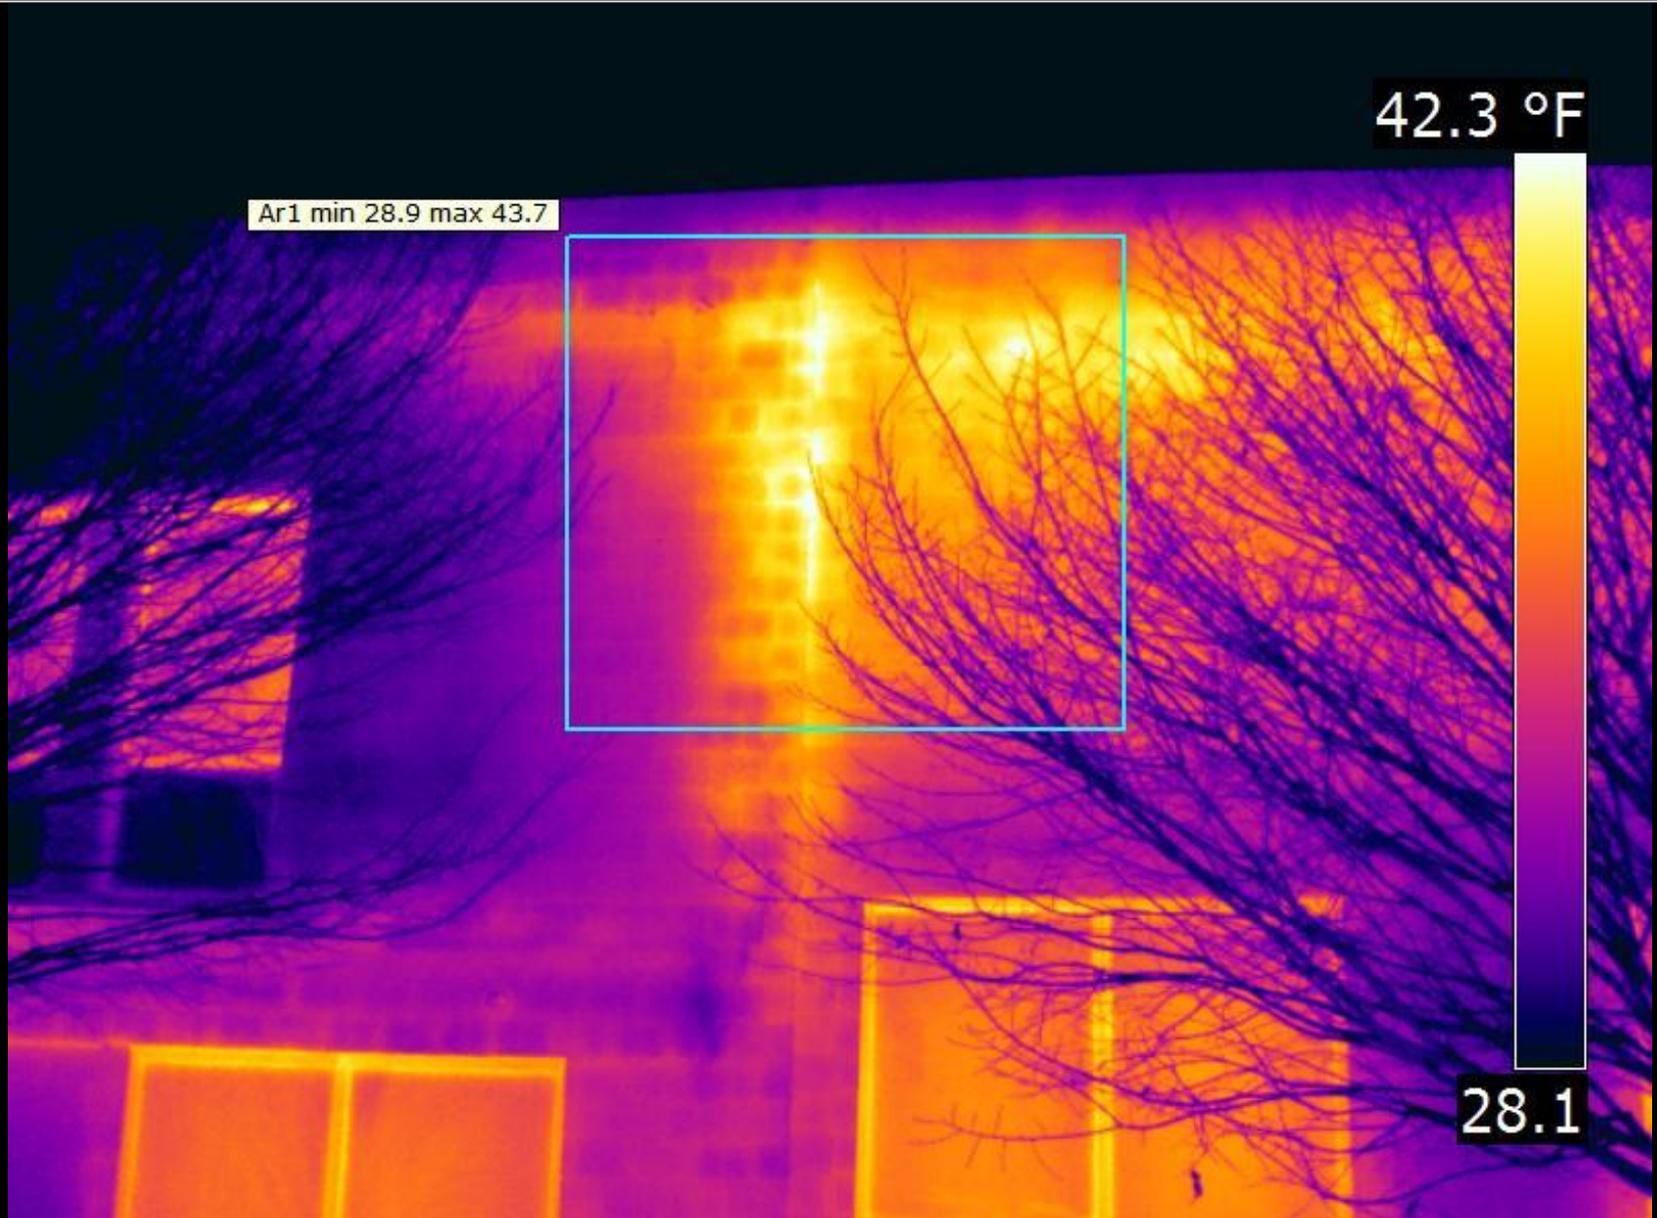
Just South of center of West-facing facade. Heat loss indicated by boxes.

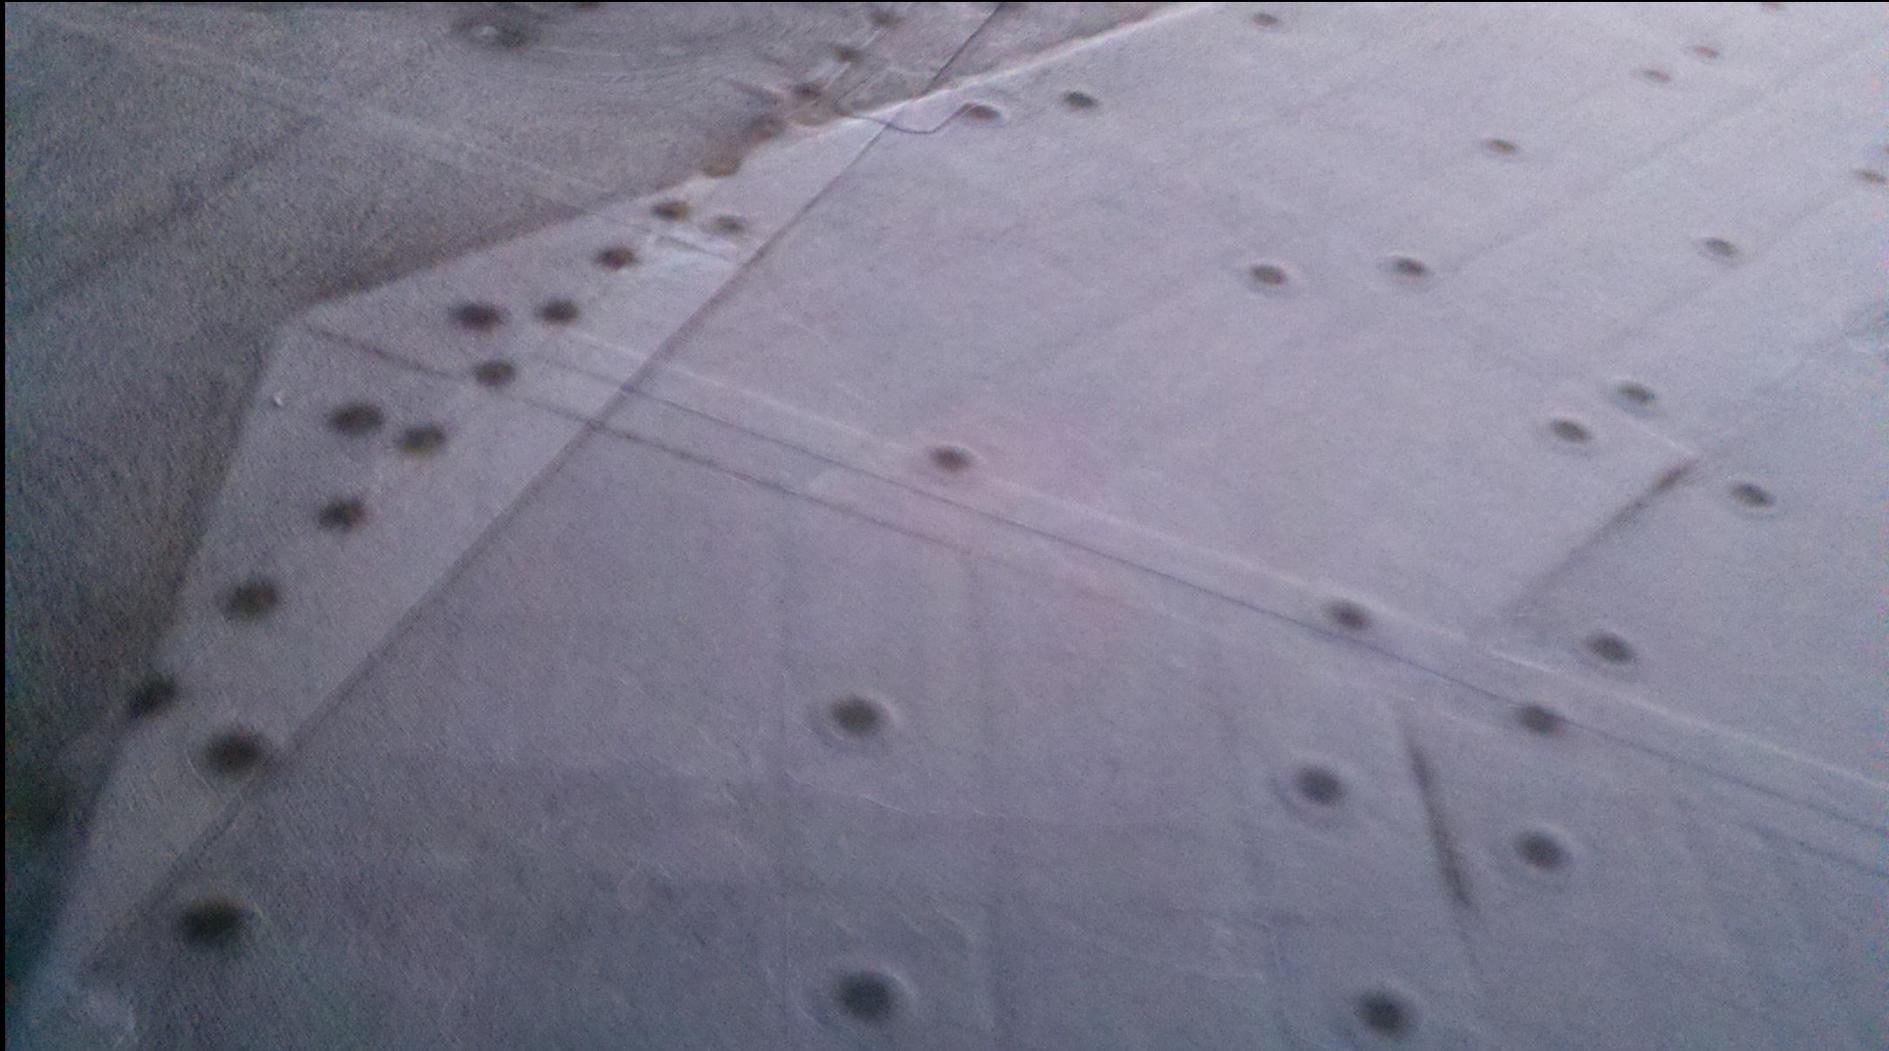
There is a significant problem with heat wicking out of the Rooftop through the thousands of long roofing nails. The above photo shows a 1/8" thick film of ice over parts of the roof. Each nail has melted completely through the ice forming a small crater.

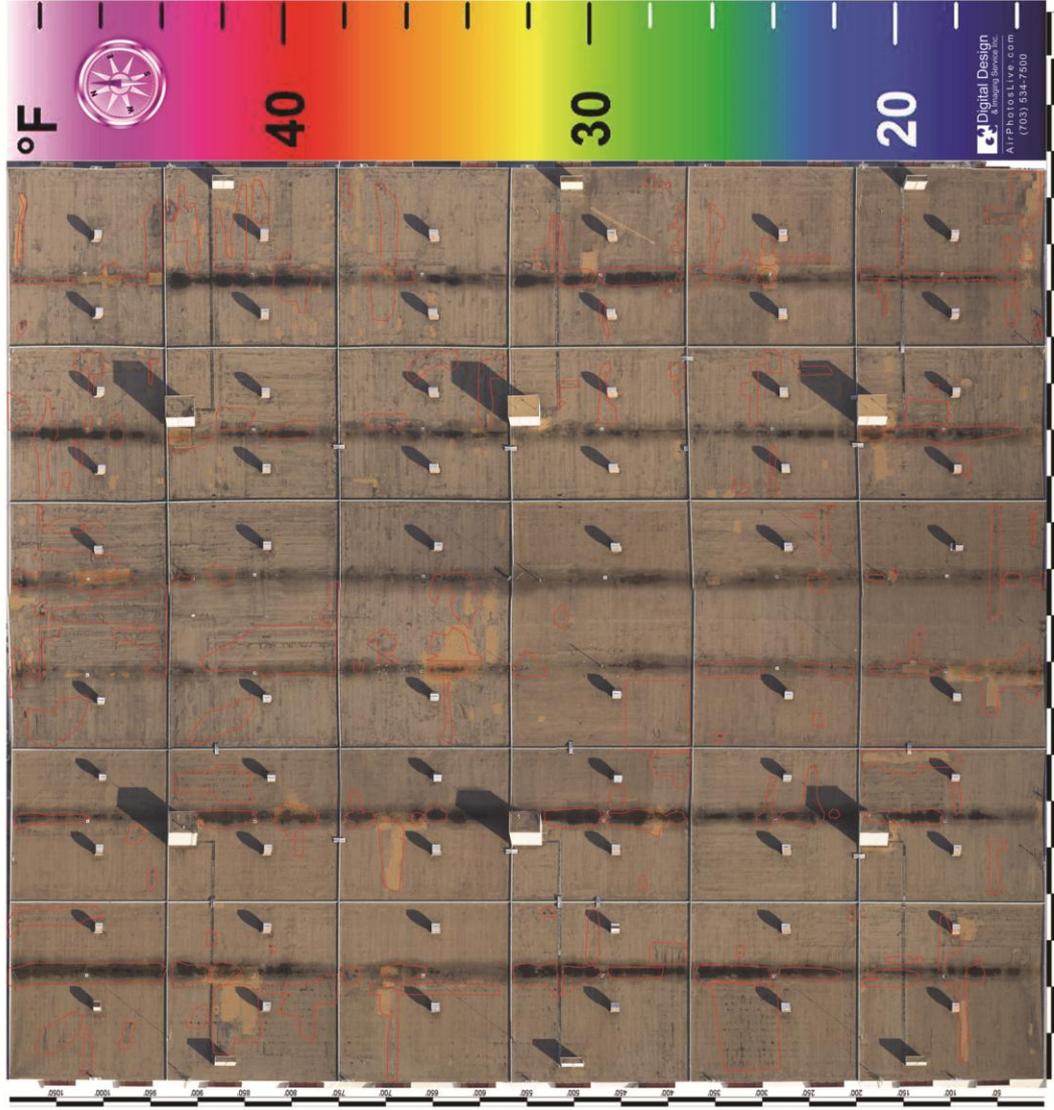
**A.03**

**BUILDING  
VISIBLE  
ROOF SURVEY**

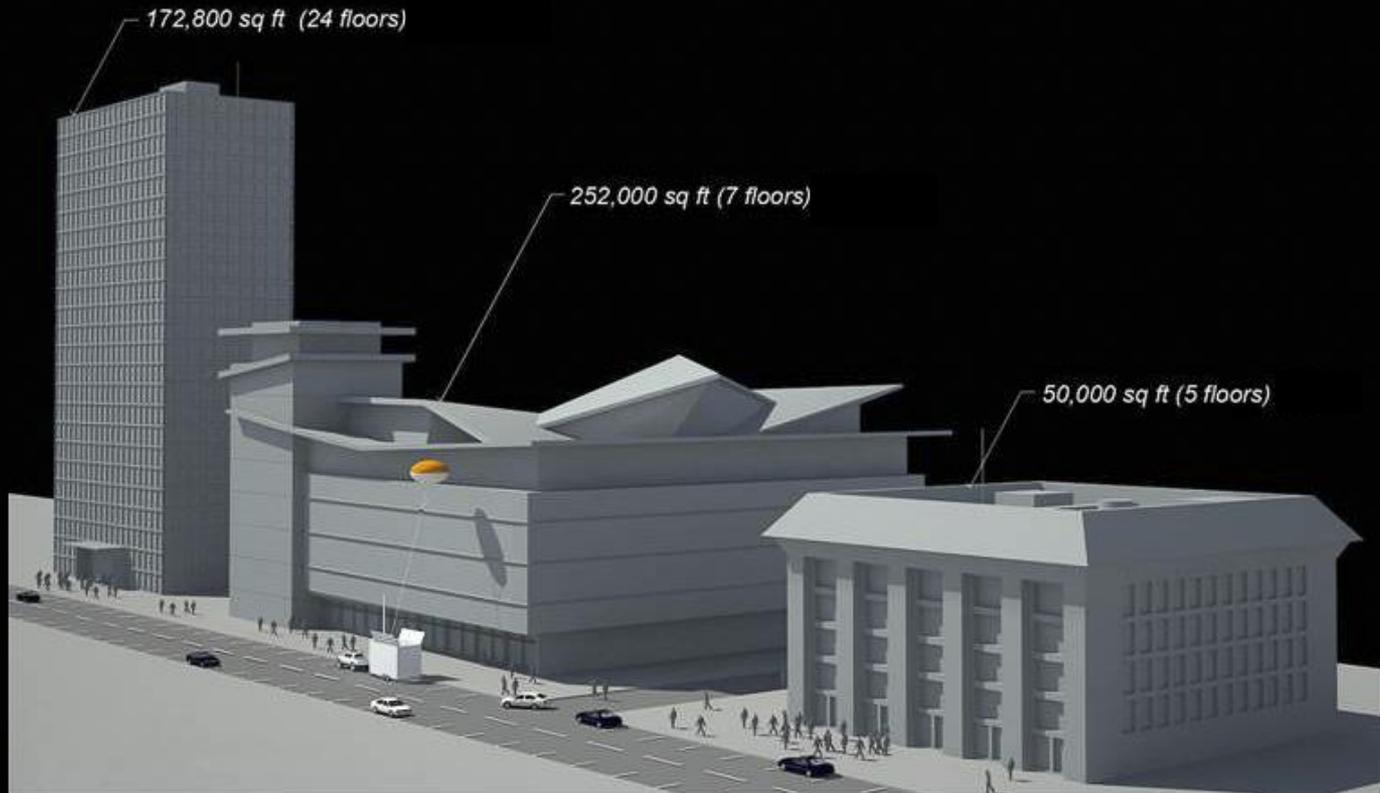
Illustration showing infrared scanning process using specialized mast and/or aerostat balloon.

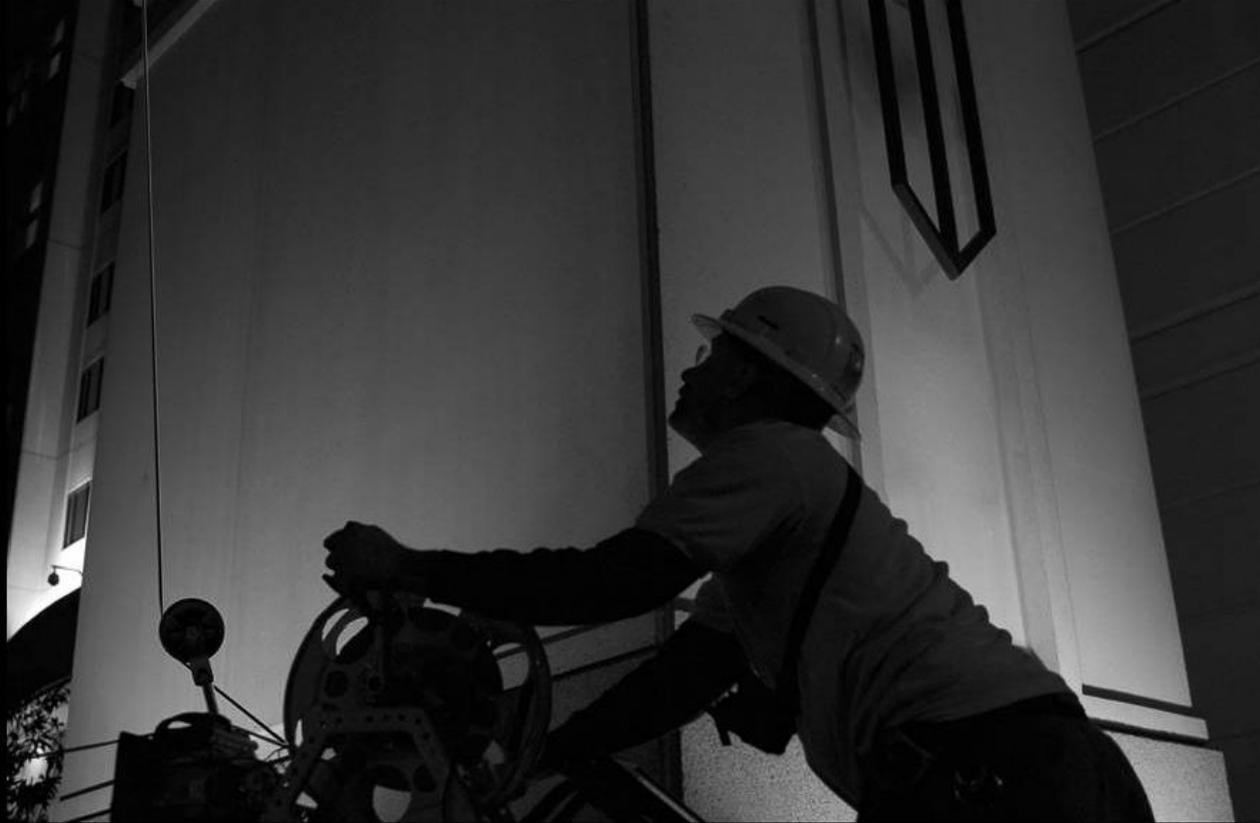
The DDIS platforms is the ultimate in Green technology: Helium does the lifting, manpower reels it in.
